Damage Assessment of a Full-Scale Six-Story Wood-Frame Building Following Triaxial Shake Table Tests

Abstract: In the summer of 2009, a full-scale midrise wood-frame building was tested under a series of simulated earthquakes on the world's largest shake table in Miki City, Japan. The objective of this series of tests was to validate a performance-based seismic design approach by qualitatively and quantitatively examining the building's seismic performance in terms of response kinematics and observed damage. This paper presents the results of detailed damage inspections following each test in a series of five shake table tests, and explains their qualitative synthesis to provide design method validation. The seismic test program had two phases. Phase I was the testing of a seven-story mixed-use building with the first story consisting of a steel special moment frame (SMF) and stories 2–7 made of light-frame wood. In Phase II, the SMF was heavily braced such that it effectively became an extension of the shake table and testing was conducted on only stories 2–7, making the building a six-story light-frame multifamily residential building instead of a mixed-use building. All earthqu

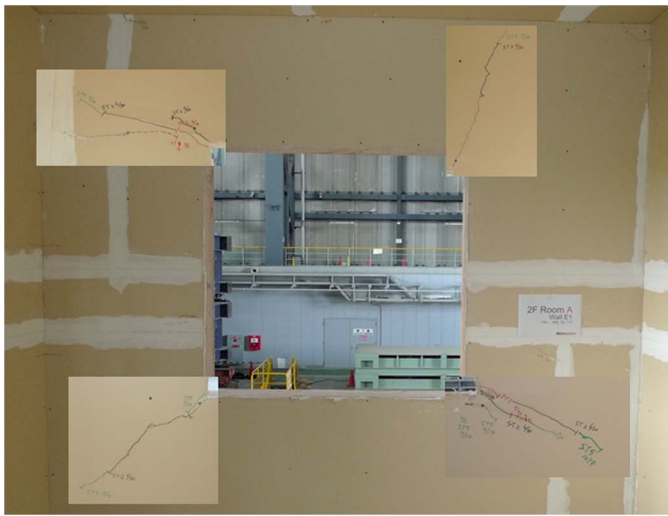
**Fig. 6.** Example of cracking propagation from the corners of a window opening after five simulated earthquake tests

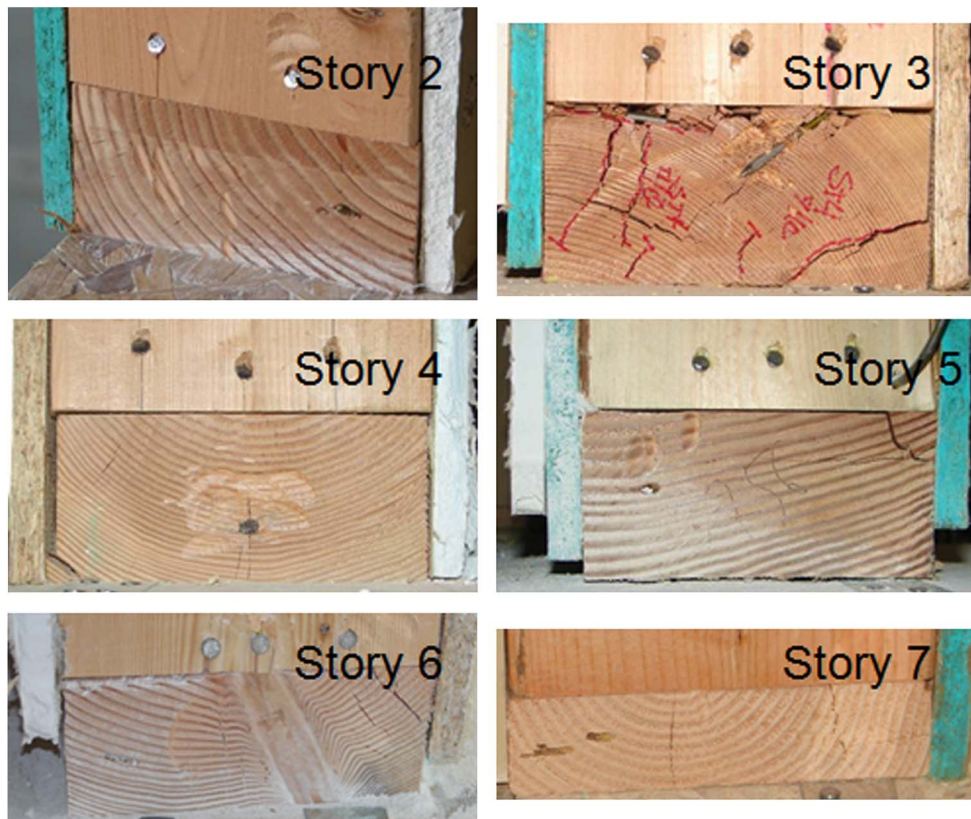
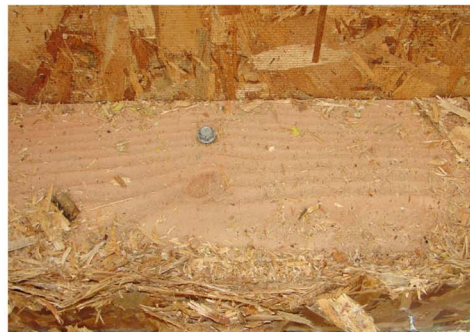
result of toe-nailing during construction and was marked as pretest damage. Fig. 7(b) shows the top of the wood screws after removing OSB on one side of the shear wall following the final seismic test. Other than the damage to GWB, no additional damage was observed, i.e., no nail withdrawal, no nail pull-through in the sheathing, and no visible stud splitting around tie-down rods. In a typical shear wall, testing without GWB failures like these are seen. But the full-scale, six-story Capstone building did not see any of these failures. This is because in shear wall testing, shear deformation is dominant, whereas in a full-scale and especially a six-story building, other deformations (such as bending and axial) are also present. Also, tie-down rods that extended the whole height of the building resisted most of the overturning forces.

Fig. 7. (a) Sill plates remaining intact (i.e., no splitting) following all five shakes; (b) close-up of sill plate after removing wall sheathing

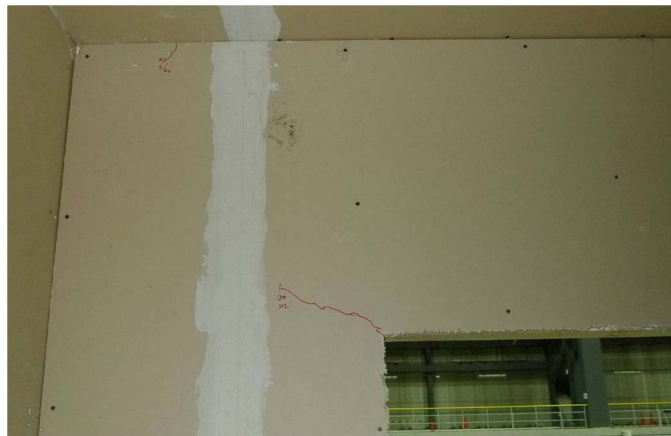
Although damage was limited to dry wall cracks only, correlation of damage to the seismic intensity test level can be identified during all five tests. In the test at Seismic Intensity Level 1, only very minor cracking was observed around the openings, as shown in Fig. 8. In many of these cases, the cracks were small enough to have been covered/filled with paint. As was anticipated, Seismic Intensity Level 2+, which slightly exceeded the design-basis earthquake (DBE), caused more damage. The cracking was definitely detectable at many locations, but was still limited to the GWB. At this

Fig. 8. Minor crack on Wall E4, Story 2 (over window opening) after Level 1 shaking

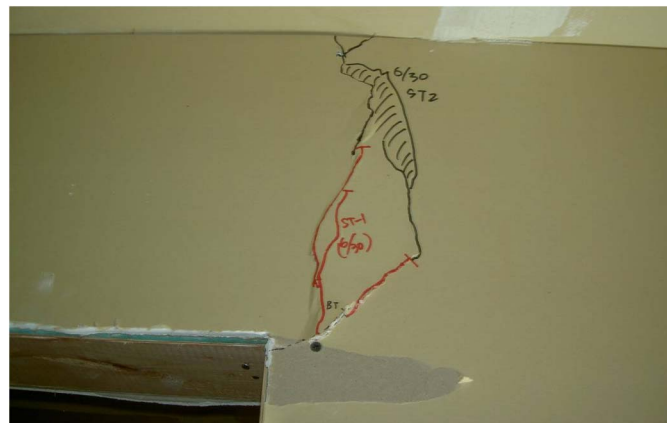
seismic intensity level, it became apparent that the stories with the larger interstory drift levels had longer, wider, and at times more numerous GWB cracks. Fig. 9 shows one of the more noticeable crack patterns that occurred above several doorways after Seismic Test 2. The diagonal pen marking indicates a section of the GWB that may have slightly pulled away, or in which the paper was loosened. Seismic Test 3 was a smaller shake, but with the steel SMF locked down, i.e., testing only the six-story wood building. During this small shake, many locations had no propagation of crack damage. For example, Fig. 10 shows a vertical crack above the doorway that occurred during Seismic Test 2 but did not widen or spall during Seismic Test 3. Because of the way the tests were performed, it is difficult to tell if the 50%/50-year earthquake used in Seismic Test 3 would have caused any appreciable damage even to the GWB. It is likely there would have been only hairline cracking such as that shown in Fig. 11.

Fig. 9. Crack on Wall D1, Story 4 (over door opening) after Seismic Test 2

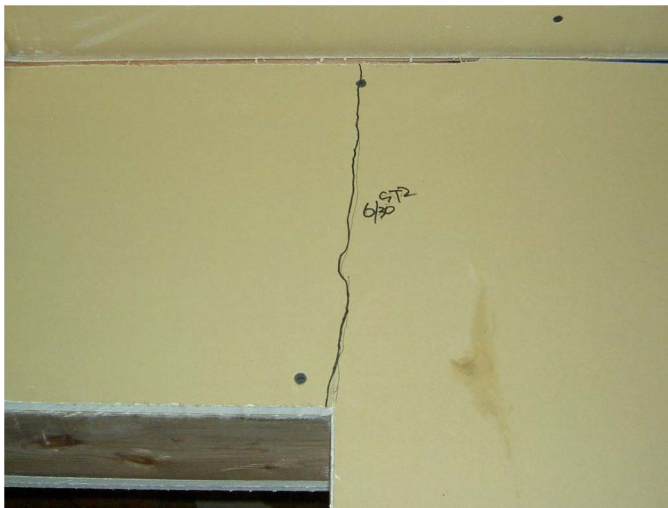
Fig. 10. No new crack on Wall 2A, Story 7 (over door opening) after Seismic Test 3; the crack shown was developed during Seismic Test 2

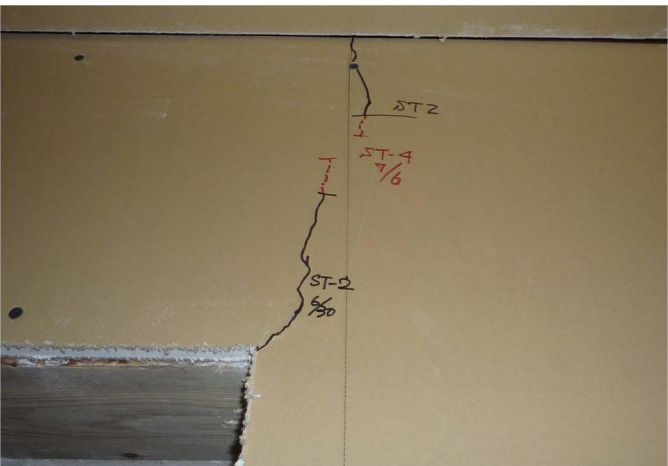
Fig. 13. Crack on Wall 2A, Story 5 (over door opening) after Seismic Test 4

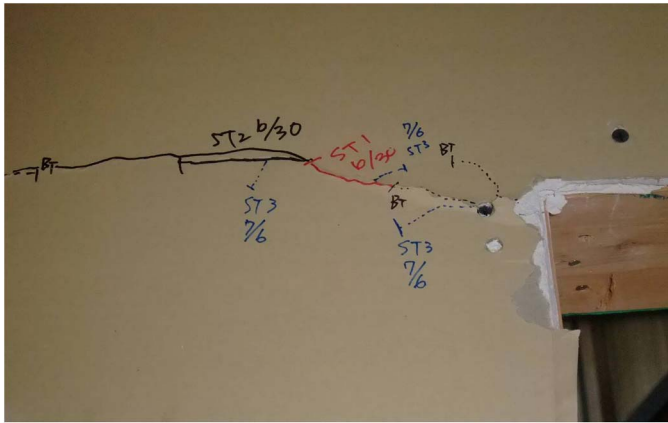
Fig. 11. Crack on Wall A3, Story 2 (over window opening)

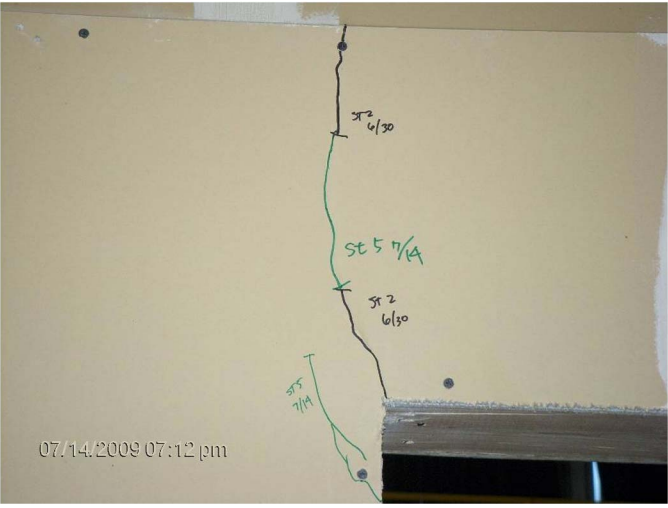
Fig. 14. Crack on Wall A3, Story 4 (over window opening) after Seismic Test 5

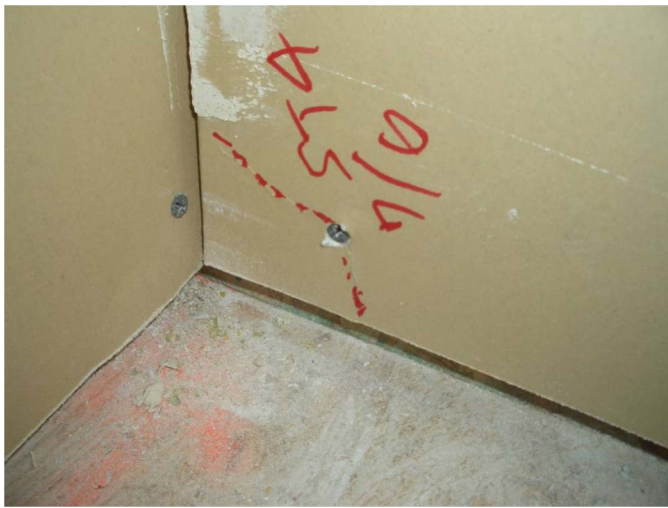
Seismic Test 4 (ST4) was a DBE level earthquake and resulted in more GWB damage. The start of some GWB spalling can be seen in the photograph. In general, Seismic Test 4 propagated existing cracks and caused some smaller cracks to branch off from the main cracks. Fig. 12 shows some new cracking near one of the corner GWB screws, indicating significant racking in the panel after ST4. The propagation discussed previously was observed routinely, as shown in Fig. 13. The “ST4” marking is for both the upward and downward propagating cracks. Repairs (structural or to the GWB) between tests were not made; thus, conclusions and correlations discussed in this paper only seek to better understand the trends.

Fig. 12. New crack on Wall D1, Story 3 (corner crushing) after Seismic Test 4

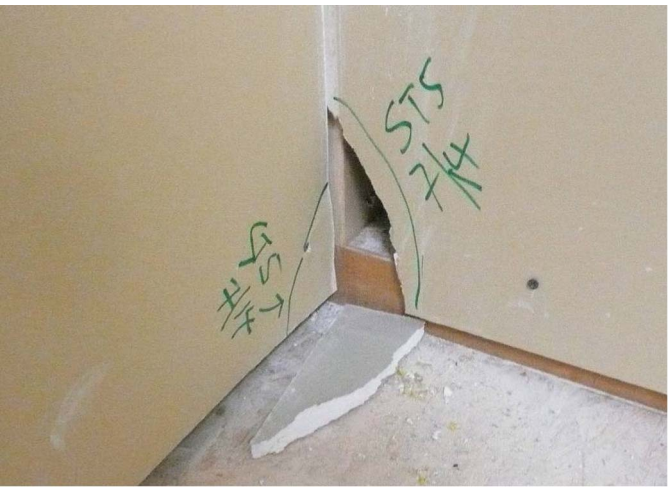
Fig. 15. Crack on Wall D2, Story 6 (corner crushing) after Seismic Test 5

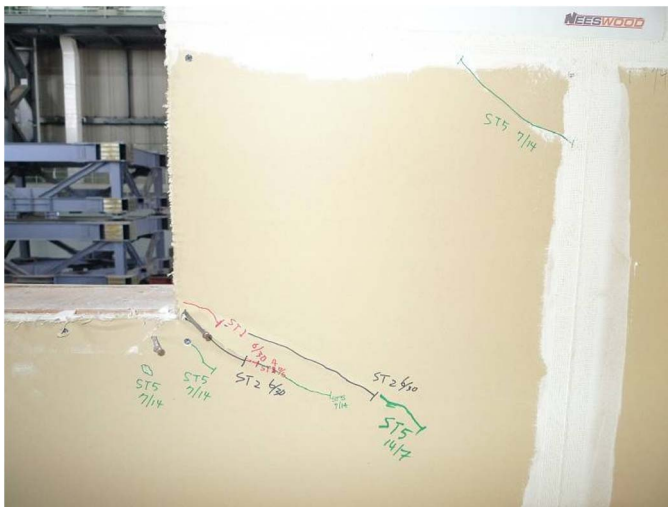
An effort is made here to qualitatively correlate damage with drift. Initially, Story 2 had a smaller interstory drift during each of the tests than Story 6 (Tables 2 and 3), yet the amount of damage was about the same at both stories. Figs. 17 and 18 show very typical damage for Story 2 after ST5. Fig. 17 shows some light spalling, but in general the cracks did not extend all the way to the panel seam or nearby wall corners. Fig. 18 shows two cracks failing to

Fig. 17. Wall E1; cracks did not extend all the way to the panel edge after Seismic Test 5

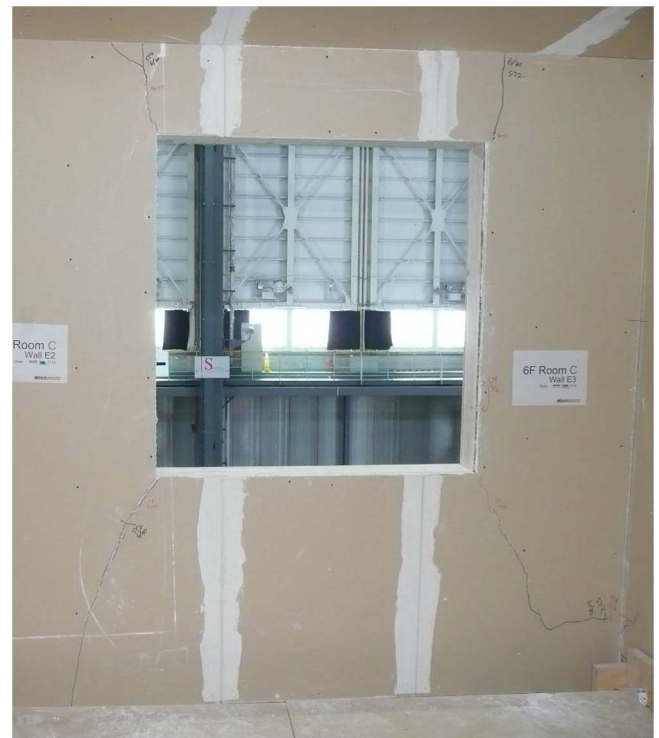
Fig. 20. Story 6, Wall E2; cracks develop all the way through panel for all corners after Seismic Test 5

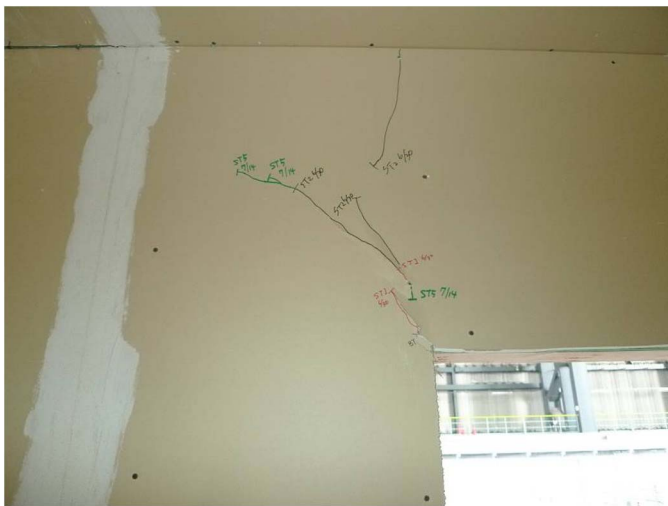
Fig. 18. Story 2, Wall E2; cracks failing to connect together after Seismic Test 5

connect following ST5 at Story 2. For some of the damaged GWB in this study, cracks tended to propagate until they connected to another crack, particularly when there was significant interstory drift caused by a combination of shear and bending. This was typical on lower stories of the building because the overall interstory drifts were lower. Comparatively, consider Story 6 following the series of five shakes. The cracks tended to propagate all the way through the panel as shown in Fig. 19. Fig. 20 shows this from a full-panel vantage point. Further, in Story 6, crushing of the panel corners was more routinely observed, as shown in Fig. 21. Most of the damage in lower stories was attributed to shear deformation,

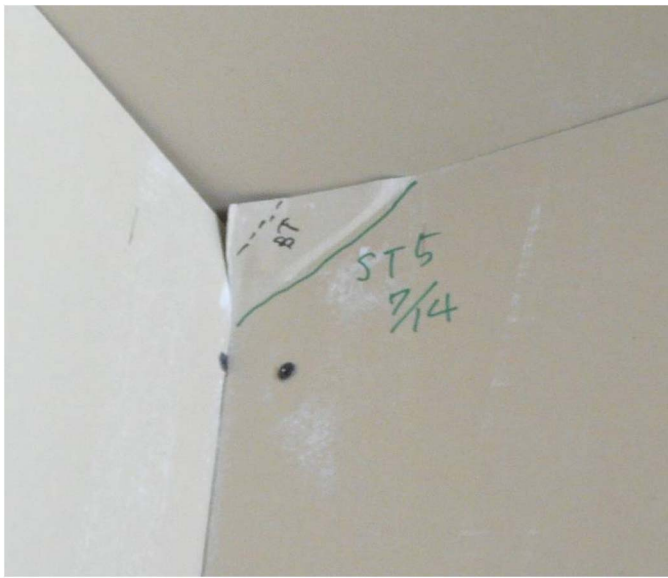
Fig. 21. Crushing of corners also seen at Story 6, Wall E5 after seismic test

whereas in upper stories the damage was attributed to a combination of shear and bending.
