Dynamic load test on progressive collapse resistance of fully assembled precast concrete frame structures

Yun Zhou^{a,b,c}, Xiang Hu^c, Yilin Pei^c, Hyeon-Jong Hwang^{d,*}, Taiping Chen^c, Weijian Yi^c,
Lu Deng^{c,1}

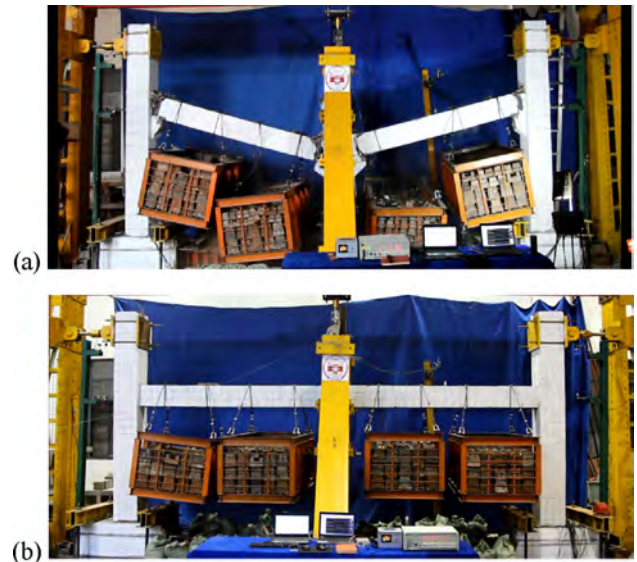
Fig. 5. Failure mode of specimens at the end of the 4th load step: (a) PC specimen; (b) RC specimen.

Table 3 shows the load conditions for the dynamic loading test. As shown in Fig. 5, the PC specimen failed at the 4th load step, while the RC specimen failed at the 6th load step. The release time was kept within 0.020–0.030 s except for the 1st and 2nd load steps, because the release time was affected by the weight of applied loads as well as the human-controlled pulling out of the pin rod on the quick-release device.

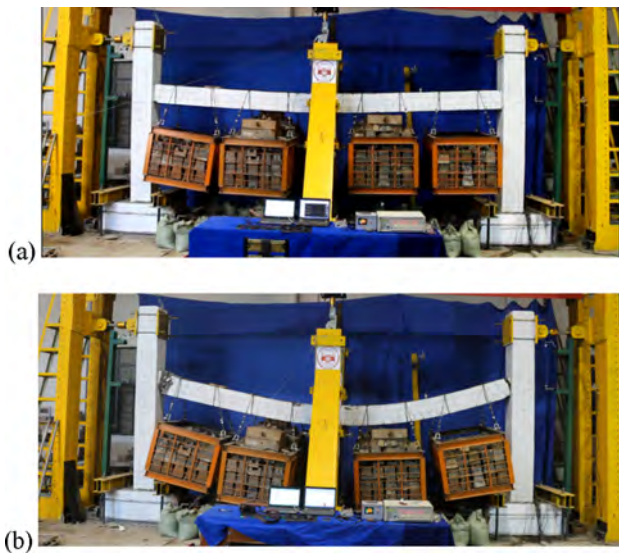
Fig. 6. Failure mode of RC specimen at the end of the 6th load step: (a) damage condition at the end of the test; (b) collapse condition after 20 min of the test.

The RC specimen did not immediately collapse at the end of the 6th load step (Fig. 6). Fig. 7(a) shows the crack distribution in the RC specimen. Concrete crushing slightly occurred on the top surface close to the interior beam-column joint, and cracks appeared on the surface of both sides of the beam (Fig. 8).
